# Analysis of Southern Segment of Sumatran Fault Monitoring Bench Mark as Preliminary Approach in Updating Earthquake Hazard Map

**Abstract.** Sumatran Fault is one of hazard located in Sumatra Island. Southern segment of Sumatran fault is one of sources of earthquakes in Lampung Province. Hazard map is used as consideration in developing region. The source of hazard comes from stress accumulation of crust which can be derived from movement of points in surface. The study of points or monitoring bench mark to accommodate more precise fault movement or slip and stress accumulation is important for sustainable development in Lampung Province. Tool used for analysis is geographic information system especially buffer analysis. Available monitoring bench mark is analysed so that each bench mark can be classified based on its contribution of fault movement based on distance from segment of current fault. High class bench marks are prioritized to be used as survey sites to monitor fault movement. The other analysis is analysis to obtain region that lack bench mark to monitor segment of current fault or even discover new fault which is branch of segment of current fault. The result of thi

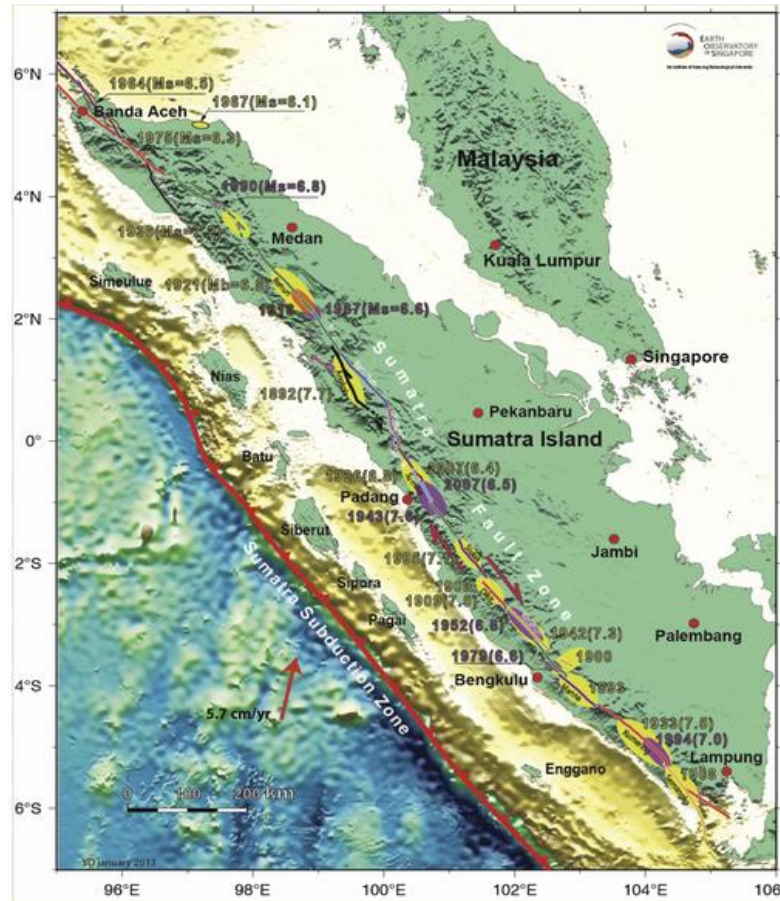
Figure 1. Sumatran Fault [1]

Sumatran Fault generate many great earthquakes in past shown in **Figure 1** [1]. Sixteen great earthquakes with magnitude more than 5 was occurred in southern segment of Sumatran Fault in last two years [2]. Monitoring of Sumatran Fault is focused on northern segment of Sumatran Fault especially after the occurrence of the 2004 Aceh earthquake which triggers activity of Sumatran Fault. Southern Segment of Sumatran Fault Monitoring is rarely conducted compared to northern segment since slip rate of northern segment is higher [3]. It makes monitoring bench marks around southern segment especially in Lampung Province is in low numbers. Fault monitoring bench marks is measured using geodetic technique to get coordinate values difference over time that generate fault parameters such as slip rate, locking depth, and segmentation [4].

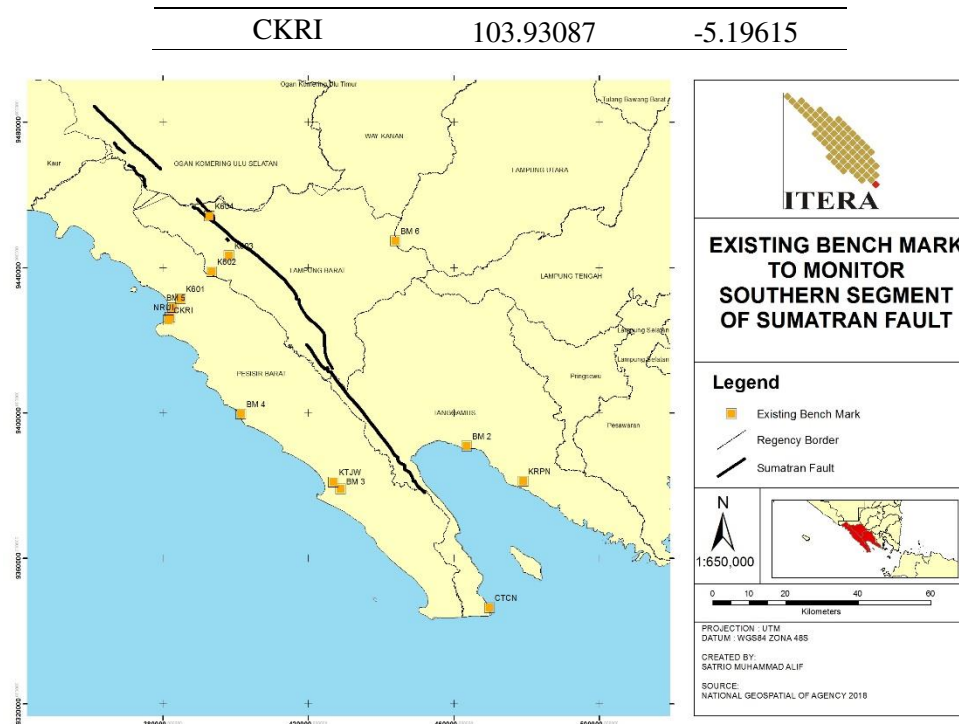
**Figure 2.** Existing bench mark to monitor southern segment of Sumatran Fault

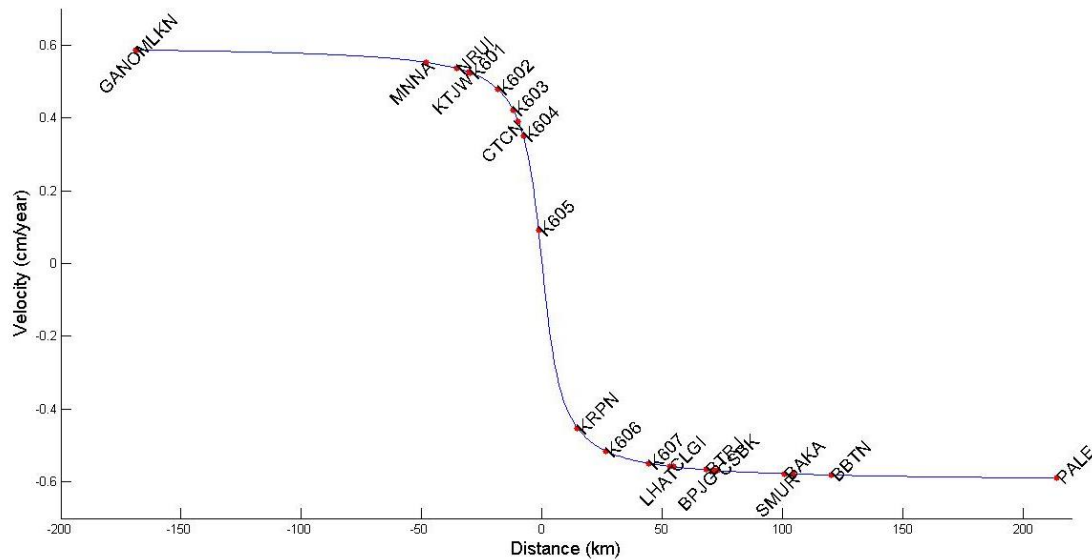
**Figure 3.** Sumatran fault slip model [7]

**Figure 3** shows the velocity trend changes due to Sumatran fault distance value in 15 kilometres from Sumatran fault. It means threshold between bench mark which classified as high class bench marks and low class bench marks is in 15 kilometres from Sumatran fault. Bench mark with perpendicular distance less than 15 km is classified as high class bench marks, while the other bench marks classified as low class bench marks. Separation of those existing bench marks can be seen on **Figure 4**. High class bench marks means those bench marks is in high priority to be used to monitor the fault since the distance is closer to fault.

Classification based on perpendicular distance between existing bench marks and Sumatran Fault using Sumatran Fault function with certain fault parameter from Alif [7] shown in **Figure 3**, with slip rate is 1.4 cm/yr and locking depth is 16 km.

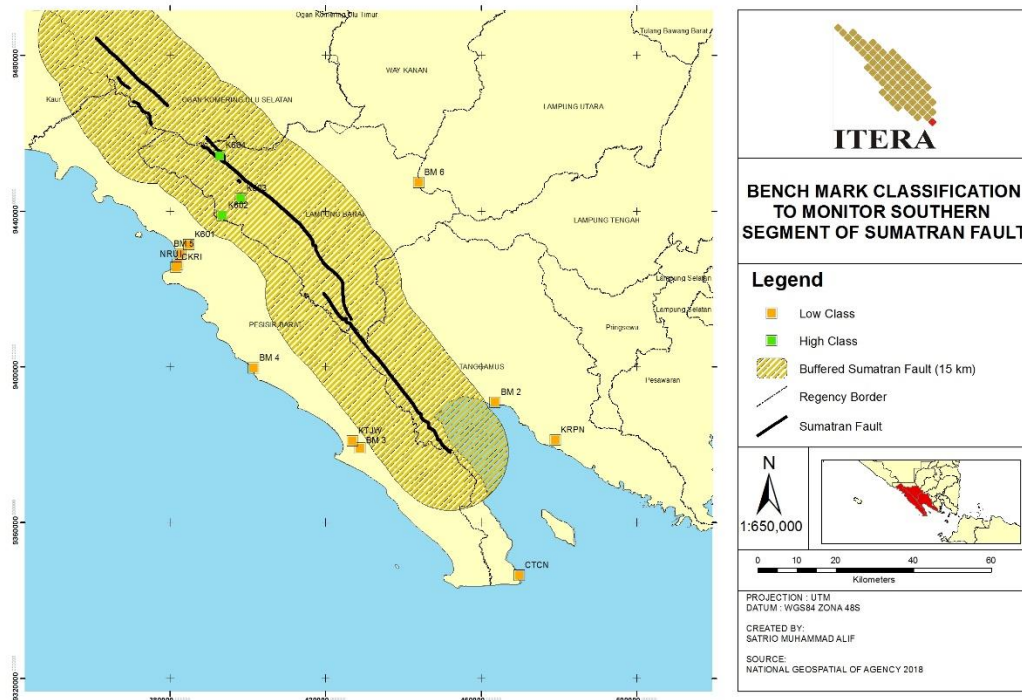
**Figure 4.** Bench mark classification

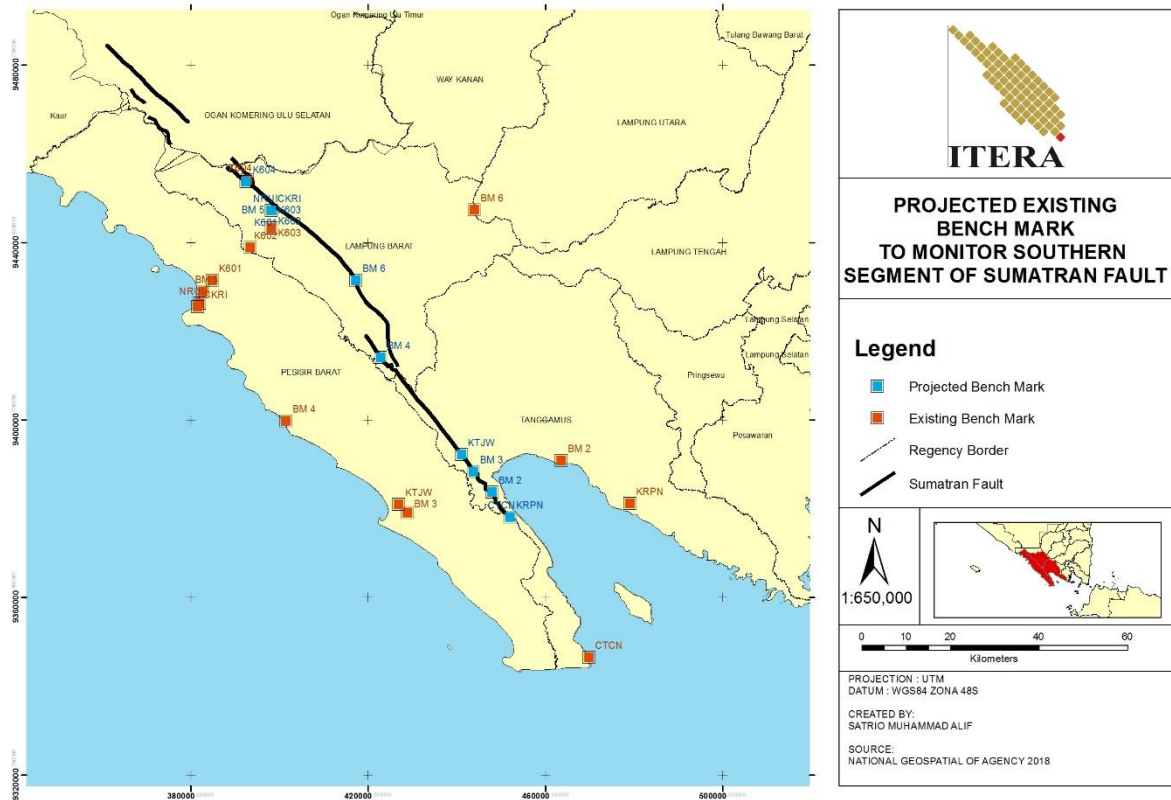
**Figure 5.** Existing bench marks and its projected points on Sumatran fault

Classification of segment of Sumatran fault which bench marks monitor is resulted by projecting bench mark perpendicularly method. The result is shown on **Figure 5**. The classification of each segment is shown on **Figure 6**. Red lines are segments with no monitoring bench marks. The length of those segments is 96.018 km or 58.54% of total segments with 164.020 km long. The possible location to monitor those segments with no monitoring bench marks is shown on **Figure 7**,

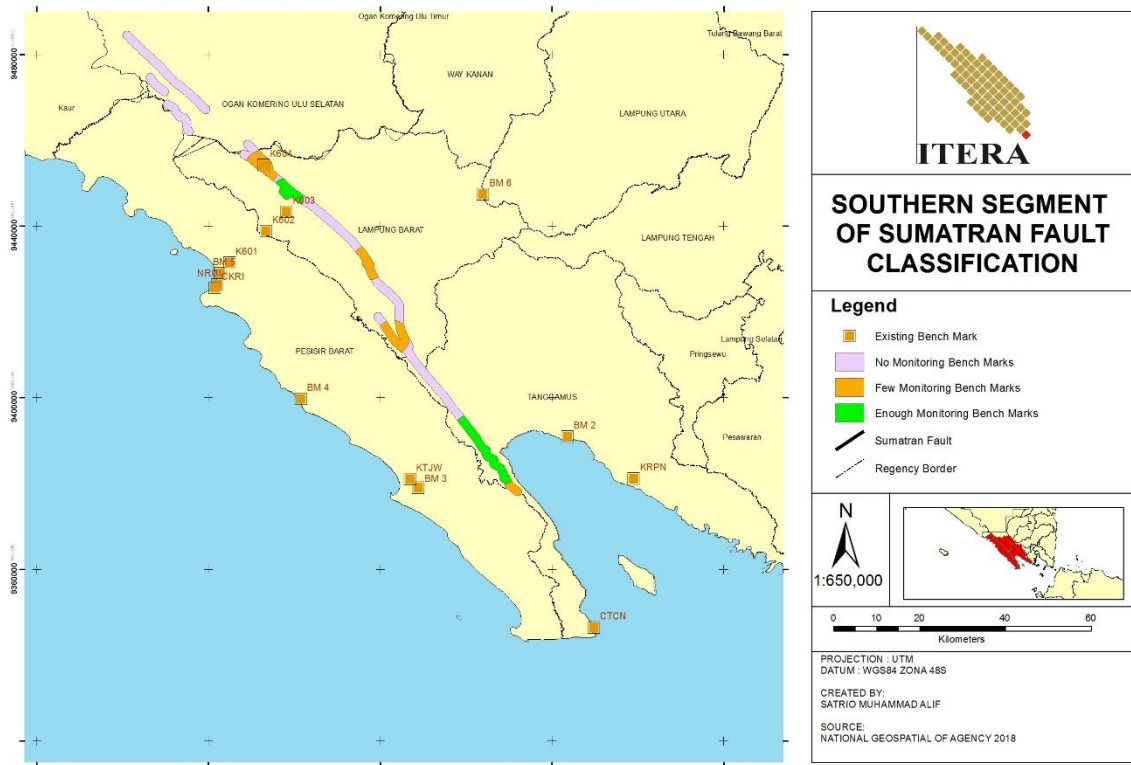
Figure 6. Classification of Sumatran fault segment based on number of bench marks projected in it

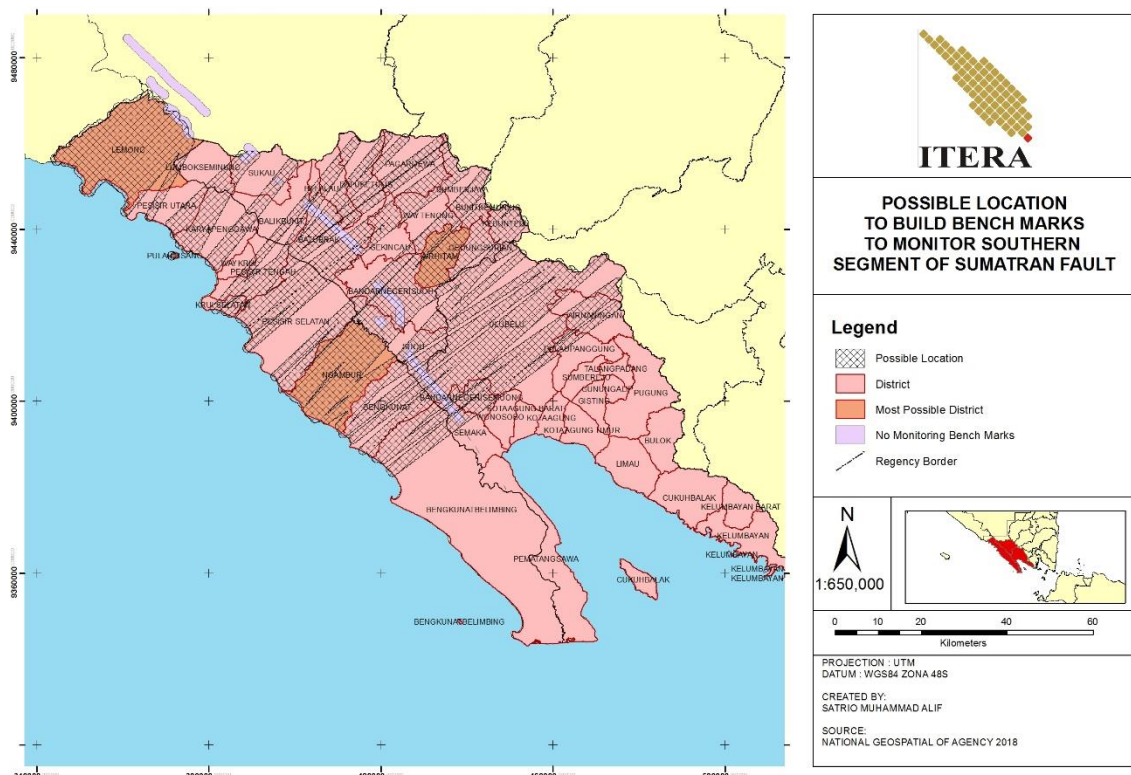
Figure 7. Possible location to monitor segments with no monitoring bench marks

**Figure 7** shows possible location related to districts in three regencies: Tanggamus, West Lampung, and West Pesisir. Based on area percentage of possible location in district, the prioritized district to build bench mark is Airhitam, Lemong, and Ngambur. The summary of the area percentage of possible location in district is shown on **Table 2**.
